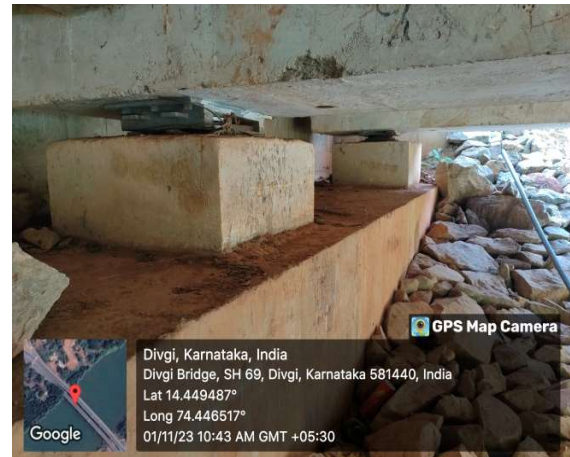
Fig: 2.1.1 Bearing

The type of bridge bearing used will depend on several factors, including the expected load weights, the span length, and the available space for accessing the bearing. The types most often used in modern bridges include elastomeric bearings, pot bearings, spherical bearings, rocker bearings, roller bearings, and sliding bearings.

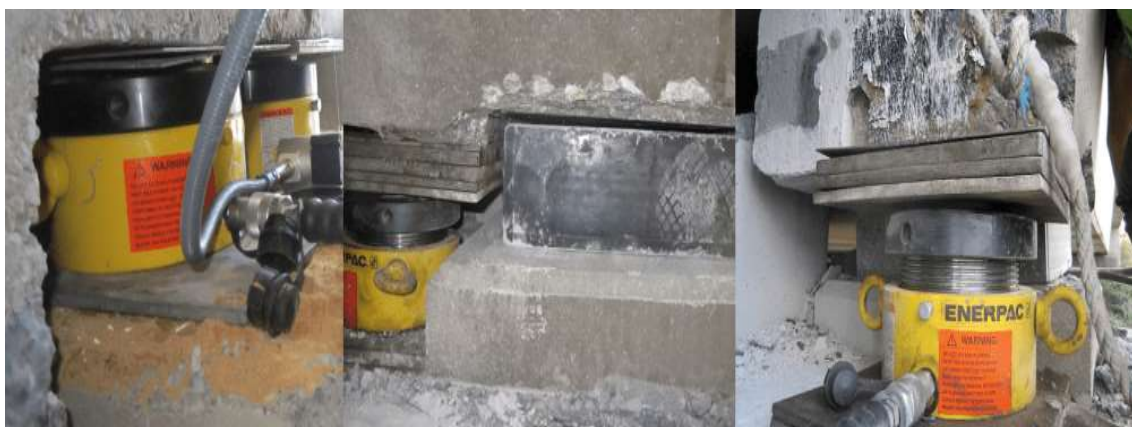
Fig: 2.1.2 Hydraulic Jack

Replacement of bearings is often done using hydraulic equipment such as cylinders (jacks or rams). While connected to a single or multiple hydraulic pump, these raise the deck beams by a small amount – just enough to free the bearings for replacement or resetting. Precise control of the jacks is needed to avoid damage to the structure. This can be achieved using split flow pumps or more advanced synchronous lifting pumps such as an Enerpac EVO Pump.

When using hydraulic jacks, these typically support the bridge beams next to the bearing being replaced. The hydraulic flow is activated, extending the cylinder plungers by a very small amount. The load is then secured mechanically using the locknut mechanism on each cylinder.

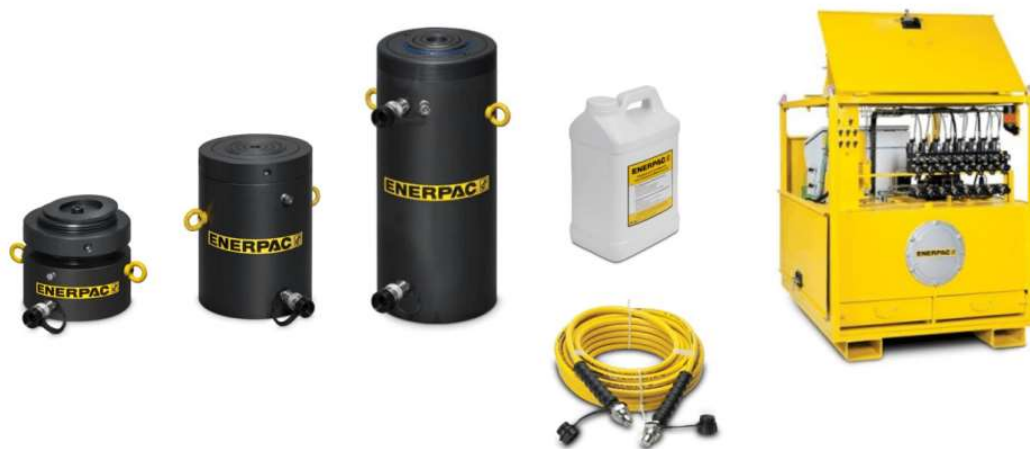
Fig: 2.1.3 Hydraulic Equipment Used For Bearing Replacement

Next, the bearing is removed, which sometimes can require the top of the supporting pedestal or mortar pad to be partially demolished. The area is then reconstructed or cleaned, before the new bearings are installed. Finally, the locknuts are deactivated and the cylinder retracted until the new bearing takes the load.

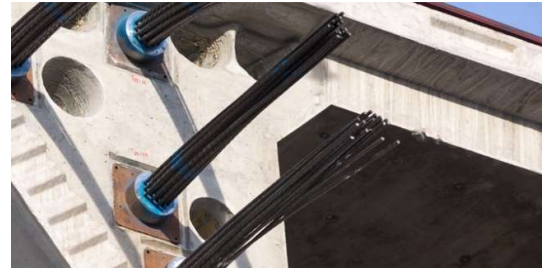
Fig: 2.1.4 Prestressed Cable

PC Strand, or prestressed concrete steel strand, is a twisted steel cable composed of 2, 3, 7 or 19 high strength steel wires and is stress-relieved (stabilized) for prestressed concrete or similar purposes.

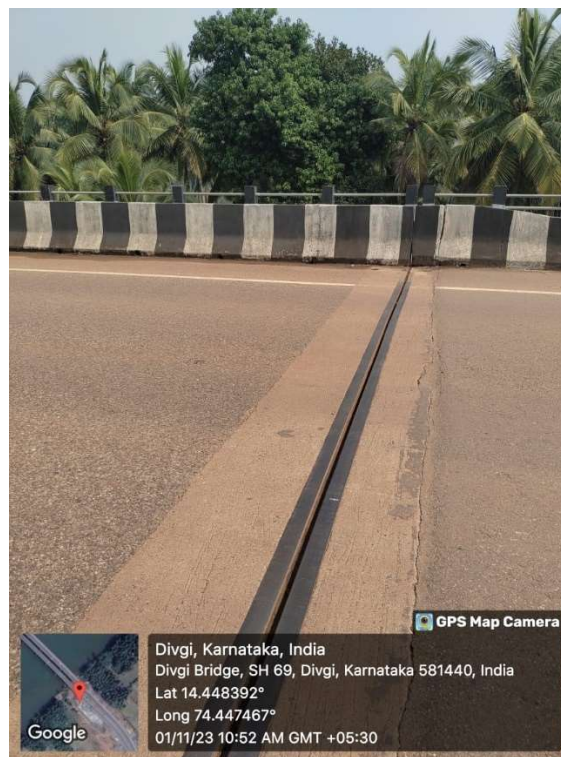
Fig 2.1.5 Expansion Joint

Bridge expansion joints are designed to adjust its length accommodating movement or deformation by external loads, shrinkage, or temperature variations, and allow for continuous traffic between bridge structures and interconnecting structures (another bridge or abutment).

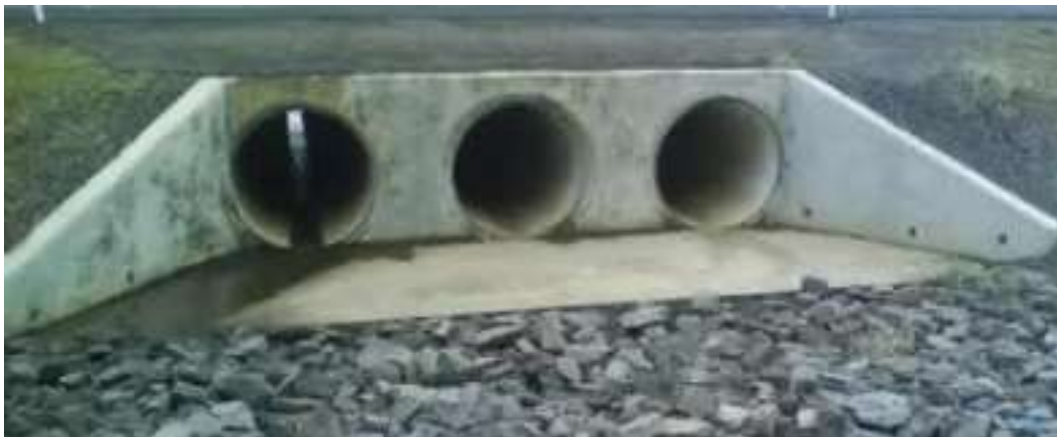
Fig.2.1.6 Pipe Culvert

Pipe culverts are rounded culverts that are widely used. Pipe Culverts can be single or multiple in number. When using a single pipe culvert, a larger diameter culvert is installed. If the channel width is greater, we will use multiple pipe culverts. They are well suited to larger flows. Pipe culverts have diameters ranging from 1 metre to 6 metres. These are made of concrete, steel, and other materials.

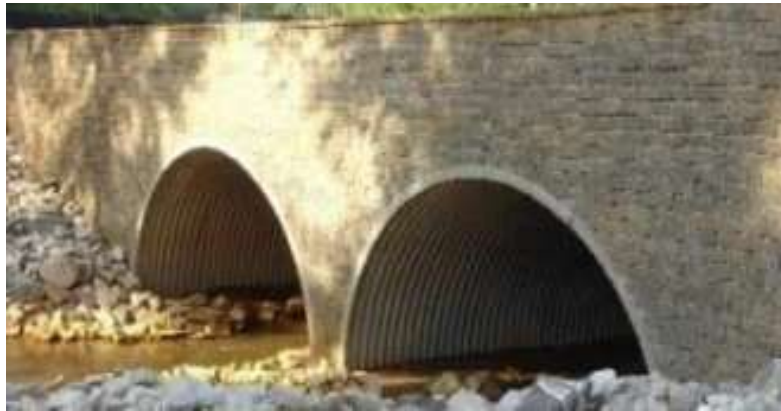
Fig.2.1.7 Pipe Arch Culvert

Pipe arch culverts mean nothing, but they resemble half circle culverts. Pipe arch culverts can handle higher water flows, but the flow must be stable. Fishes or sewage in the drainage are easily carried to the outlet due to the arch shape, as there is no stocking at the inlet or bottom of the channel. This type of culvert can also be supplied in a variety of sizes depending on the need. They also contribute to a beautiful appearance.

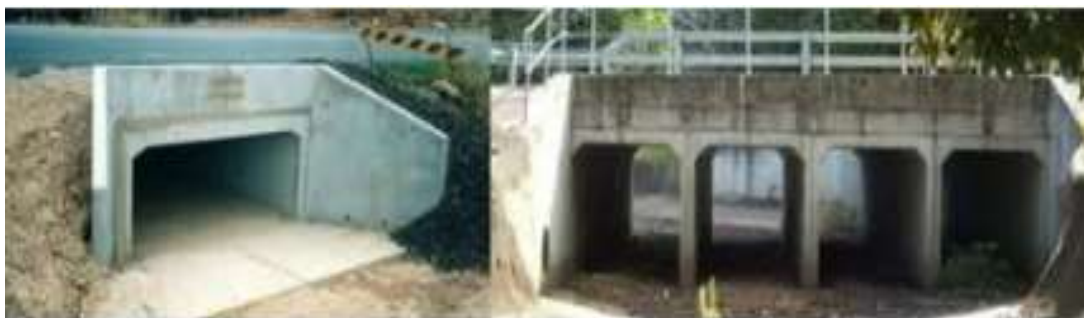
Fig.2.1.8 Box Culvert

Box culverts are rectangular in shape and are typically made of concrete. The box culvert design also includes reinforcement. These are used to get rid of rainwater. As a result, they are ineffective during the dry season. They can also be used as passageways for animals to cross the rail or roadway during dry periods. Because of the sharp corners, these are not suitable for higher velocities. Box culverts are also available in a variety of sizes.

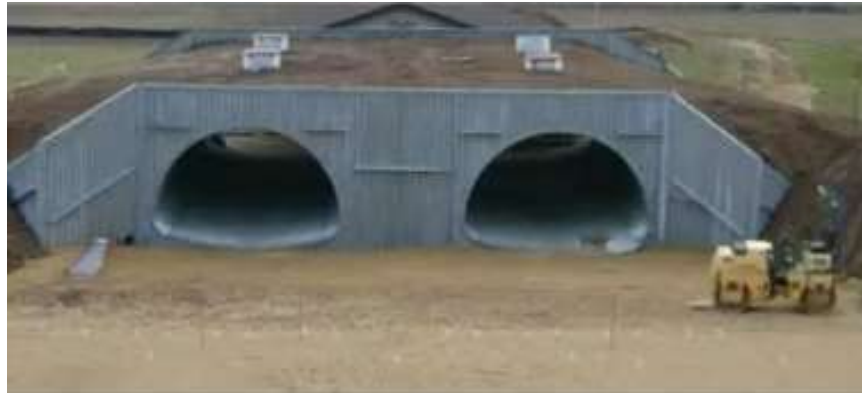
Fig.2.1.9 Arch Culvert

Arch culverts are similar to pipe arch culverts, but an artificial floor is provided beneath the arch in this case. It is commonly used in narrow passages. The artificial floor is constructed of concrete, as is the arch. Steel arch culverts are also available, but they are quite costly.

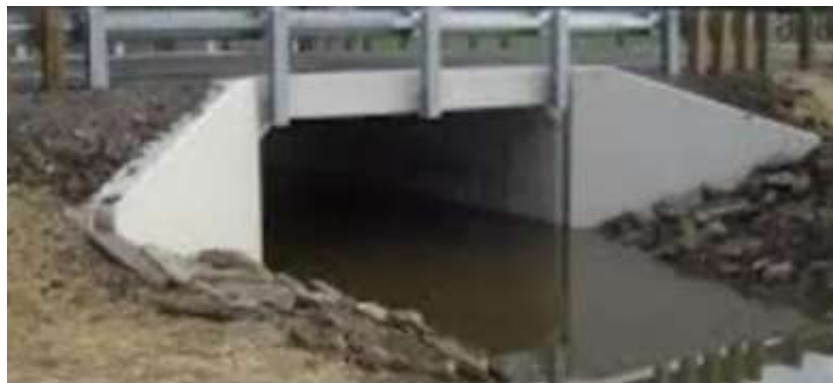
Fig: 2.1.10 Bridge culvert

Bridge culverts are provided on canals or rivers and are also used as vehicle road bridges. A foundation is laid beneath the ground surface for these culverts. A series of culverts is laid, and then a pavement surface is laid on top of the culverts. These are generally rectangular shaped culverts that can be used in place of box culverts if an artificial floor is not needed.

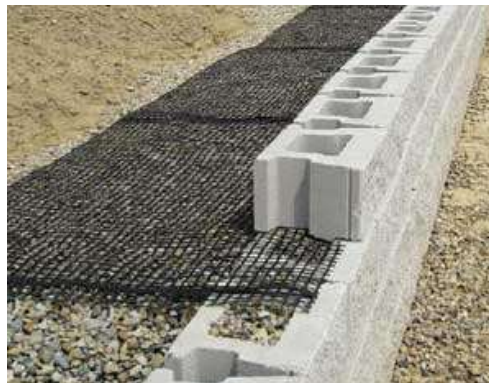
Fig: 2.1.13 Geogrid Mesh

Geogrids primarily provide a stabilisation or reinforcement function, to enhance the performance of soils. They also provide separation between soil and aggregate layers and are used widely in civil engineering applications.

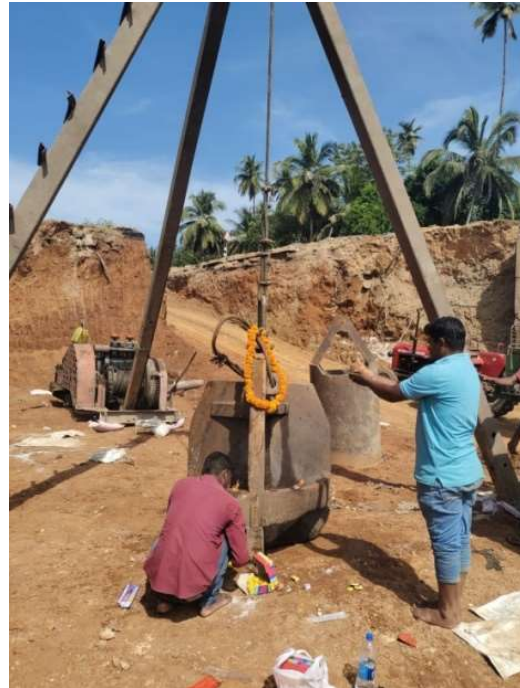
Fig 2.1.14 Pile Boring Machine

- Sheet Piles.
- Load Bearing Piles.
- End bearing Piles.
- Friction Piles.
- Soil Compactor Piles.
- Based on Materials and Construction Method.
- Timber Piles.
- Concrete Piles.

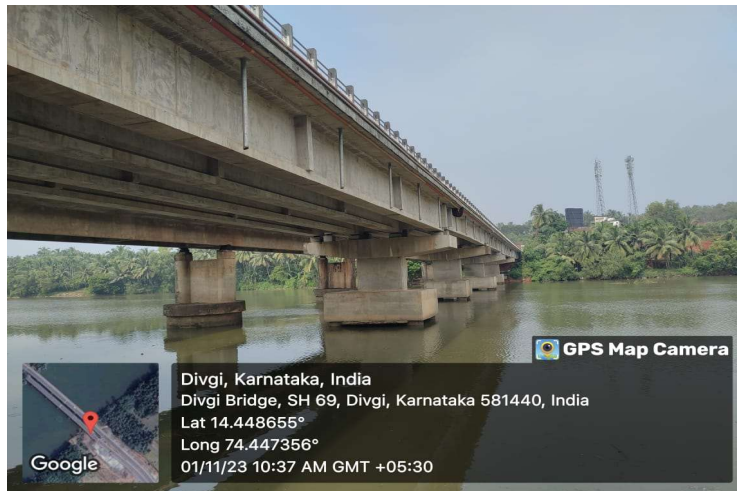
Fig 2.1.15 Bridge Pier

According to the definition, The Piers, are the vertical support structures of bridges. They are the intermediate supports, whose function is to transmit the forces they receive from the load-bearing elements to the foundations.

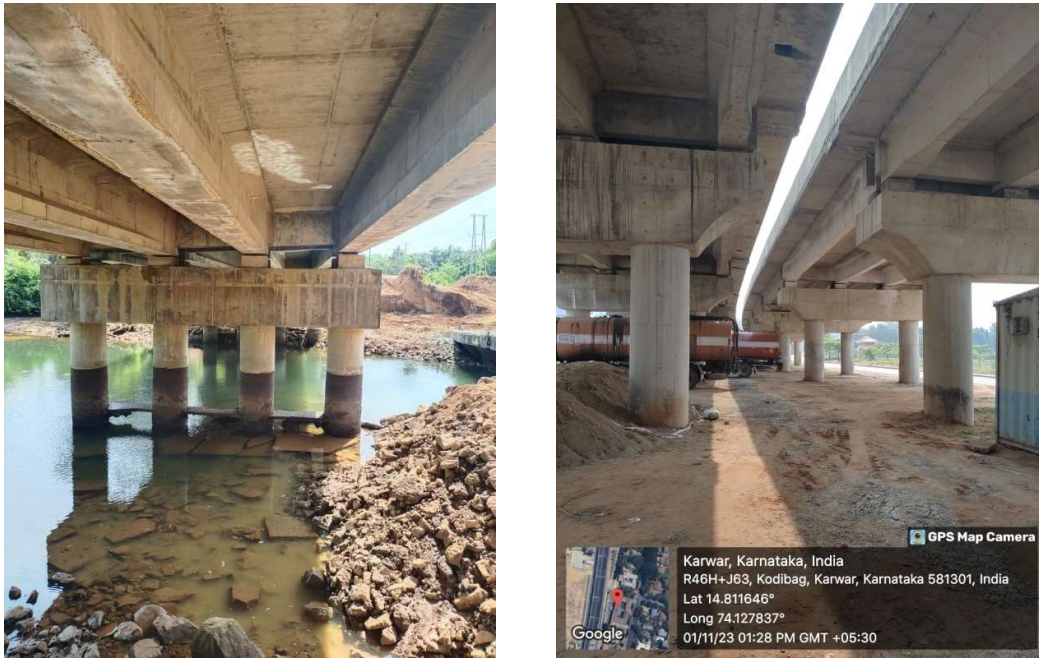
Fig 2.1.17 Bridge structures

Devgi bridge for structural details.

Various aspects of bridge was explained.

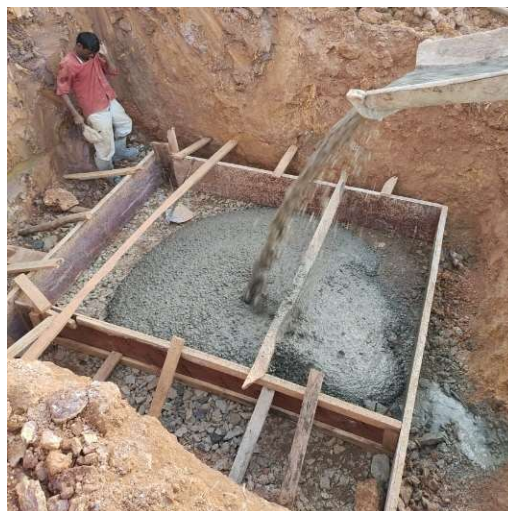
Fig 2.1.18 PCC laying

PCC is Plain Cement Concrete which is an item used in construction of Foundations like Raft Foundation and that also not as a key item. A PCC layer is laid as levelling course below the raft foundation.

PCC layer for Bridge Foundation

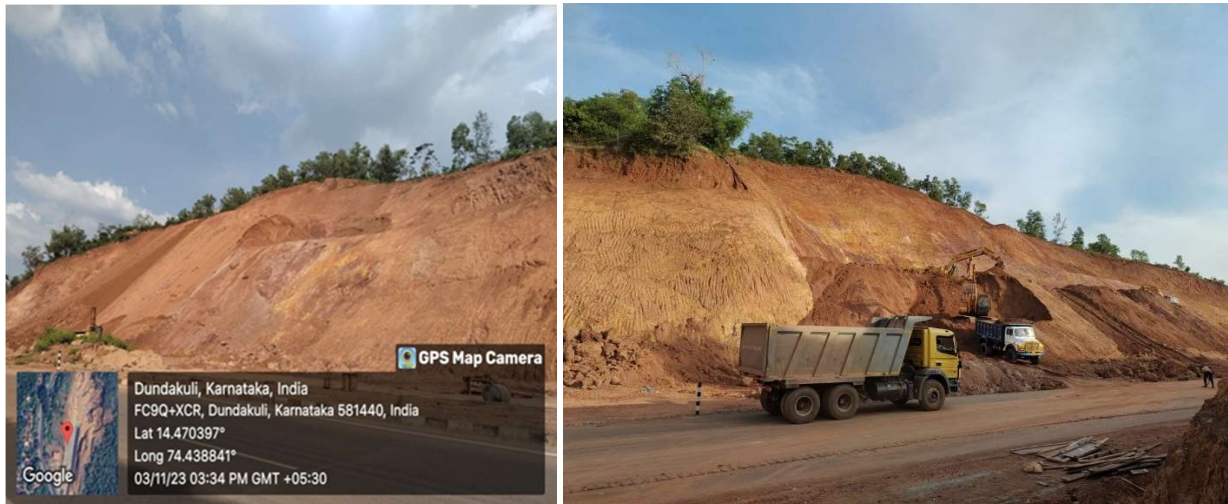
Fig. 2.2.8 Hill Cutting

Hill cutting region near Dundakuli

Along with the cutting of slope along the edges of the highway the progress of steel bridge for water supply over the highway was in progress.

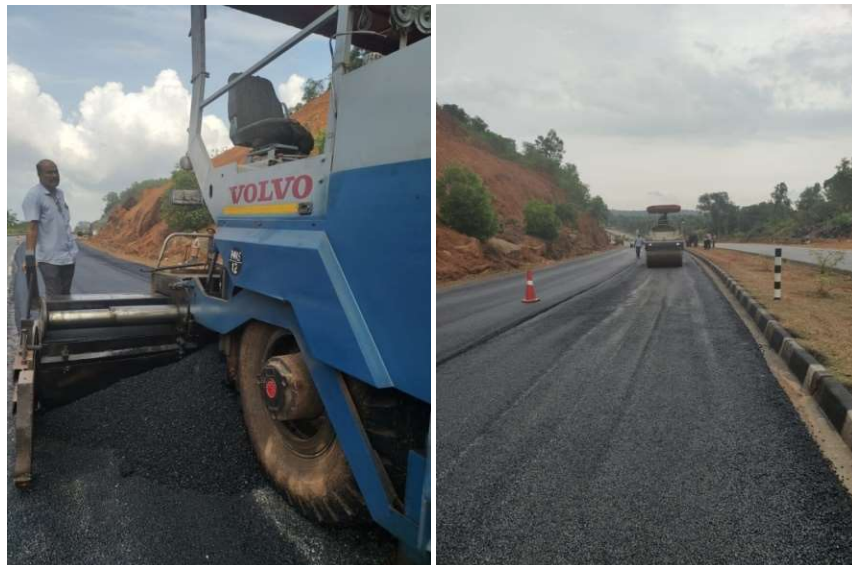
Fig.2.2.9 Laying BC layer with Paver

Laying of BC layer

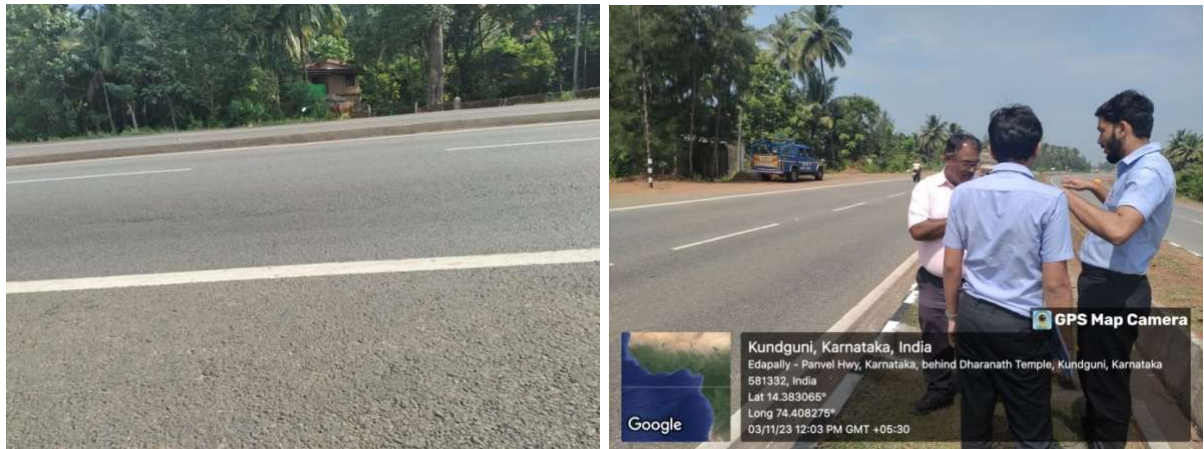
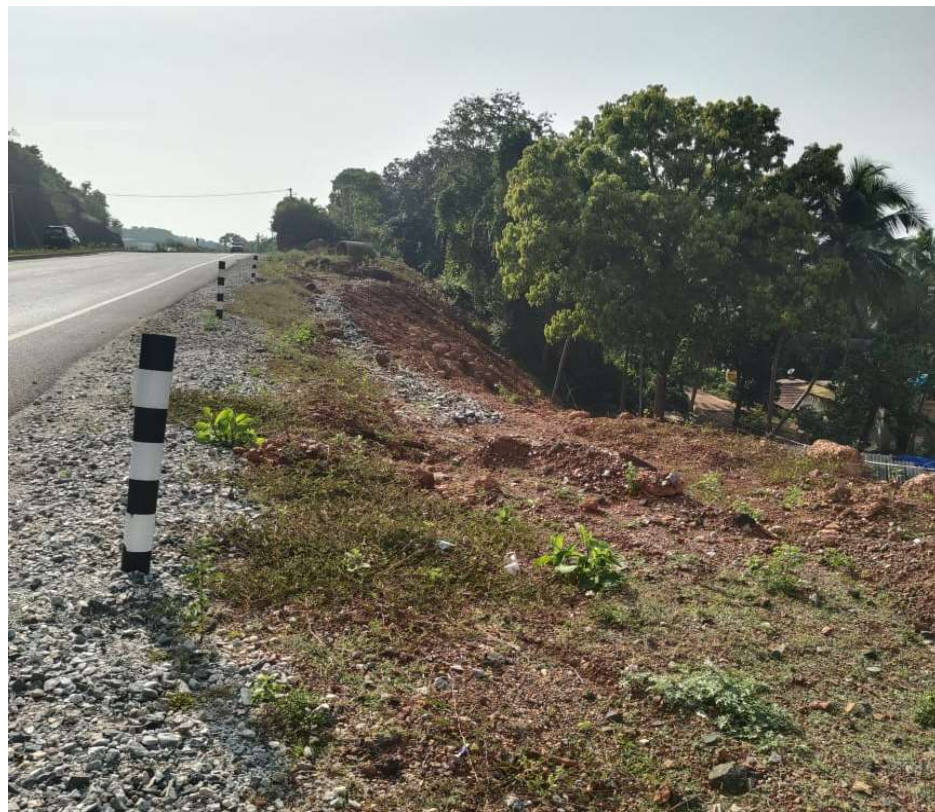
Fig.2.2.10 Highway Details

Highway cross section explanation in site.

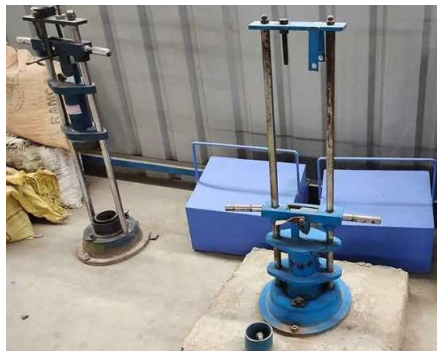
Fig 3.2 Impact value Apparatus

The aggregates must pass through 12.5 mm sieve and retain on 10 mm IS sieve. Limits for AIV, ranging from 45% maximum to 25% maximum according to the concrete surface wear expectation.

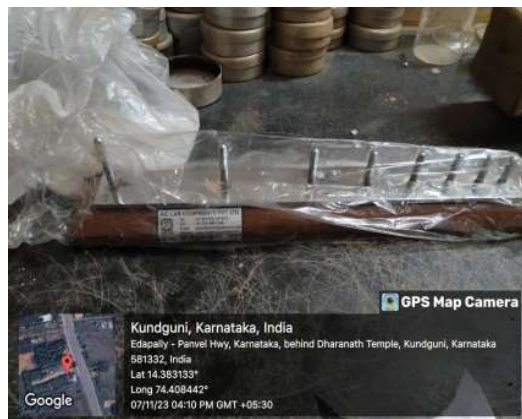
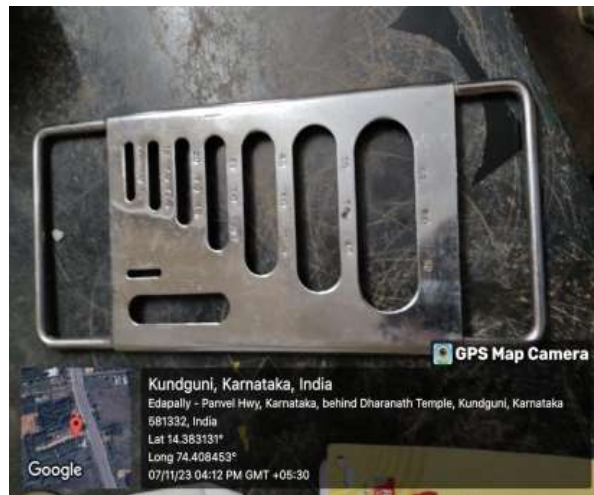
Fig 3.3 Flakiness Index and Elongation Apparatus

The percentage (by mass) of stones in an aggregate having an ALD of less than 0.6 times their average dimension . Flaky aggregates tend to produce seals with less voids due to their tendency to pack more tightly than cubical aggregates consequently flaky particles require less binder.

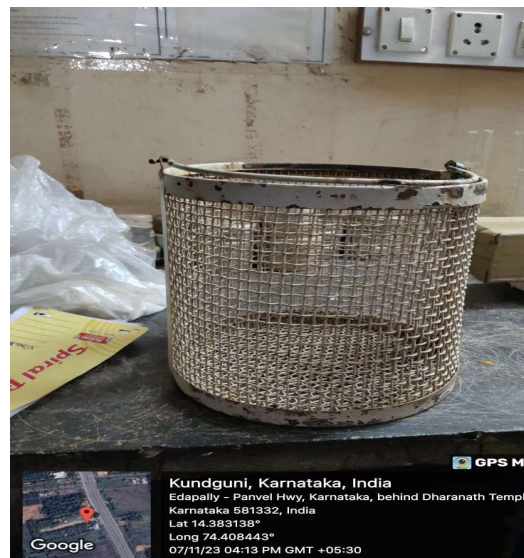
Fig 3.4 Water Absorption Apparatus

Water absorption gives an idea on the internal structure of aggregate. Aggregates having more absorption are more porous in nature and are generally considered unsuitable, unless found to be acceptable based on strength, impact and hardness tests.

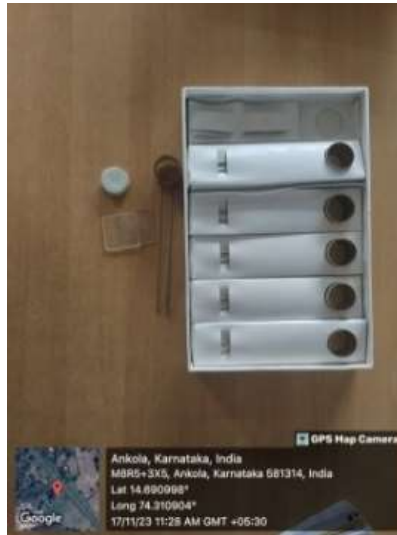
Fig 3.11 Le Chatliers Apparatus

This test is conducted in Le Chatelier's apparatus to detect the presence of uncombined lime and magnesia in cement.

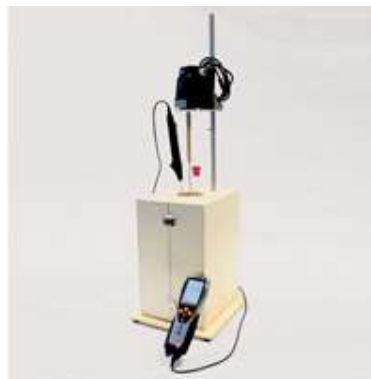
Fig 3.12 Calorimeter

This test is carried out using a calorimeter adopting the principle of determining heat gain. It is concluded that Low-heat cement should not generate 65 calories per gram of cement in 7 days and 75 calories per gram of cement in 28 days.

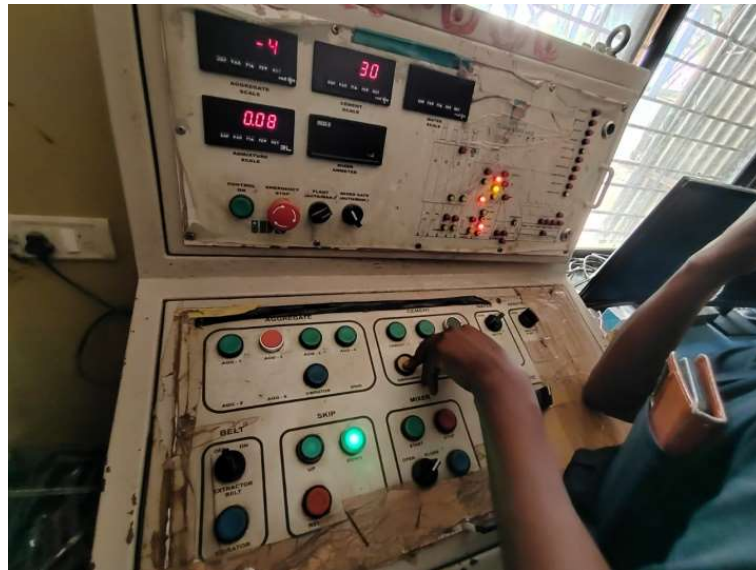
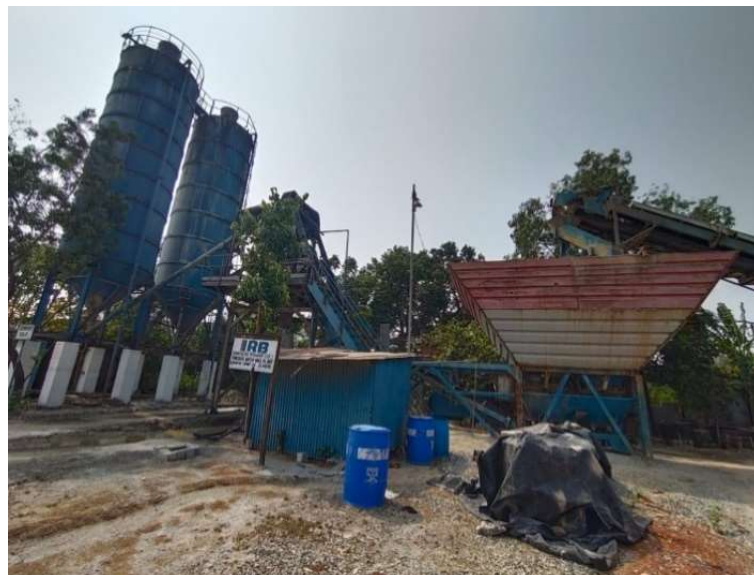
Fig 3.14 Ready Mix Concrete Plant

The ready mix concrete plant is used to manufacture ready-mix concrete which is used in all the construction projects. The ready-mix concrete is also known as RMC is a mixture of cement, water, sand and aggregates. It is manufactured in a batching plant as per the required specifications of a construction project.

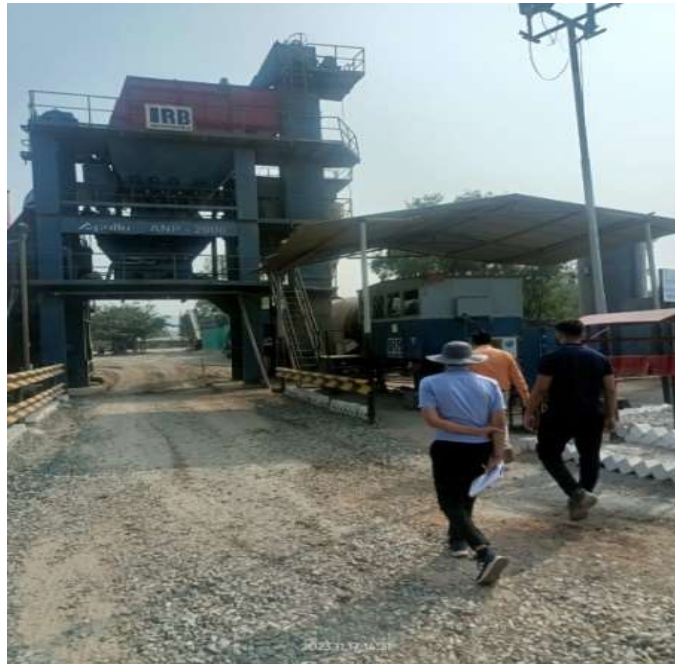
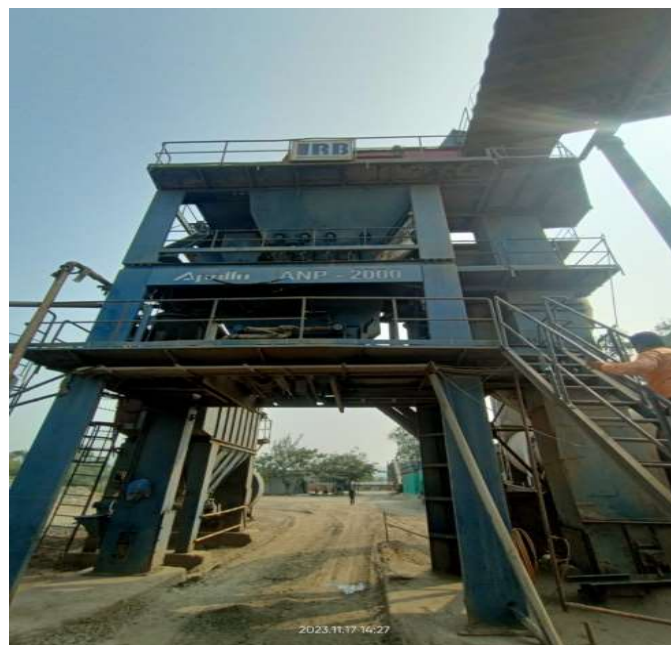
Fig 3.15 Bituminous Mixing Plant

A bitumen mixing plant, also called asphalt mixing plant, is road surface paving material production equipment that is used to blend cold aggregate, liquid bitumen, and other admixture to form asphalt mix or blacktop, which is widely used for road construction.

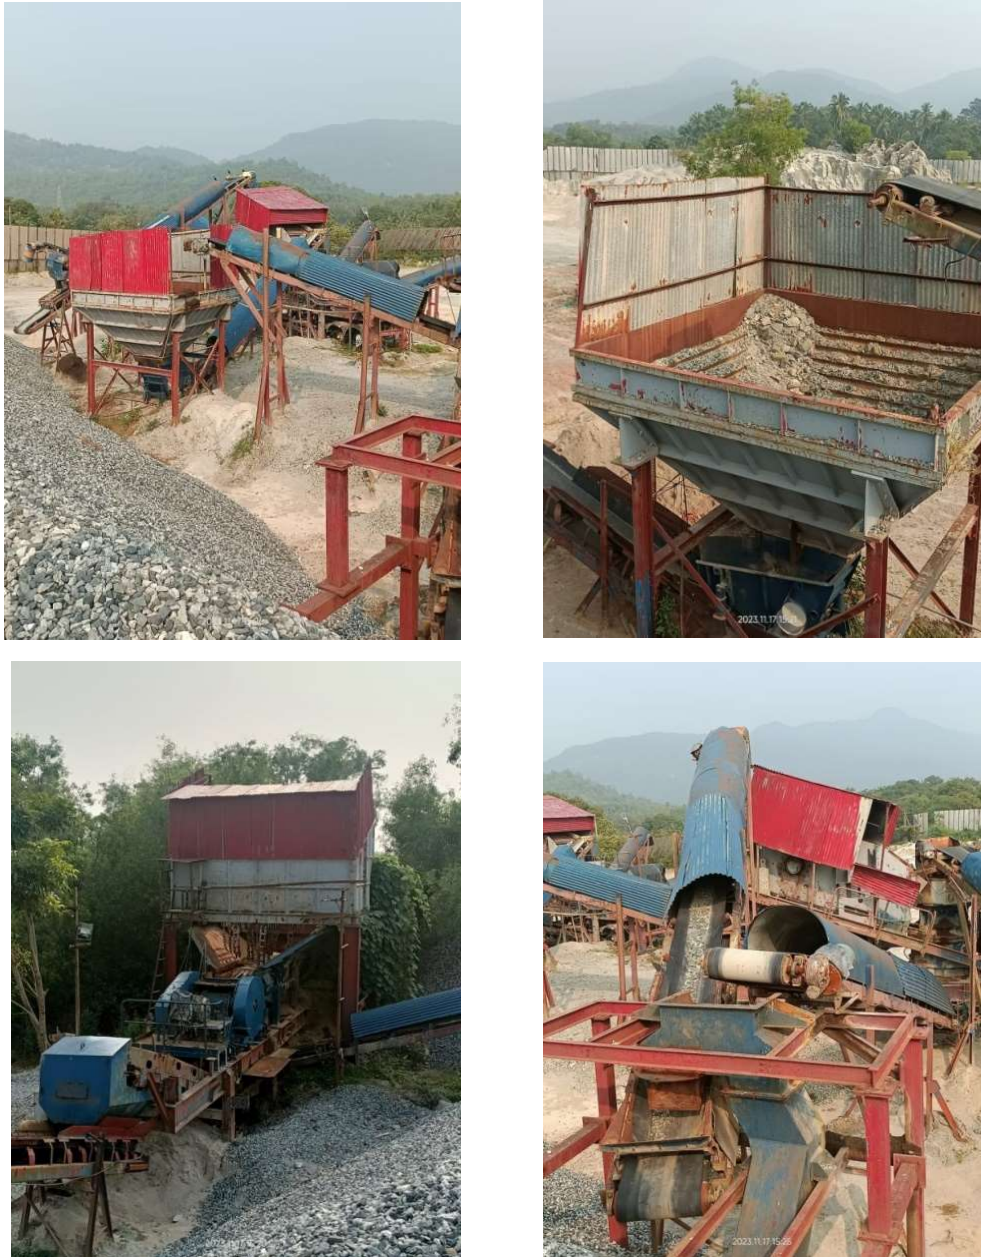
Fig 3.16 Crushing Plant

A crushing plant setup is a series of machines that are designed to take large pieces of concrete, asphalt or rock and break them into smaller pieces. The crushed material can then be used for construction, landscaping, and other purposes.

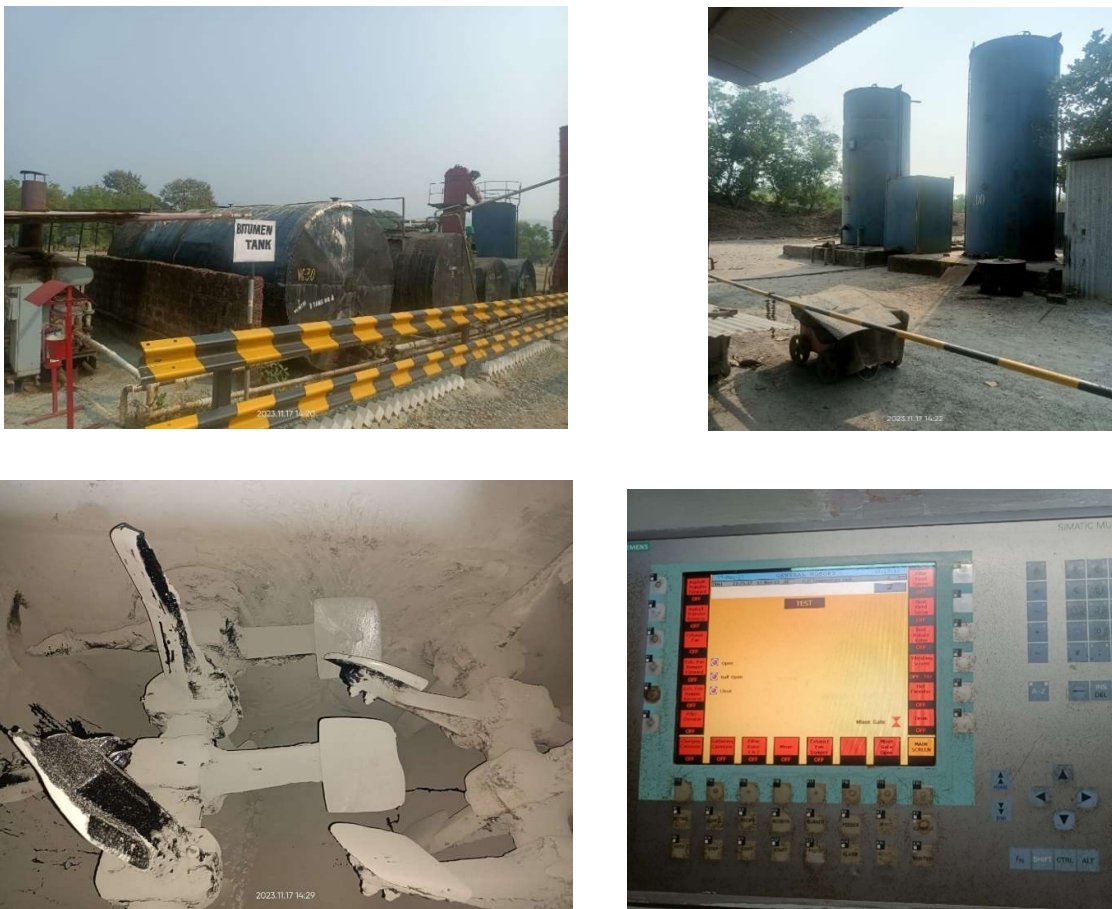
Fig.3.18 Bituminous mixing Plant

3.8.2 Explanation about Bituminous mixing Plant:

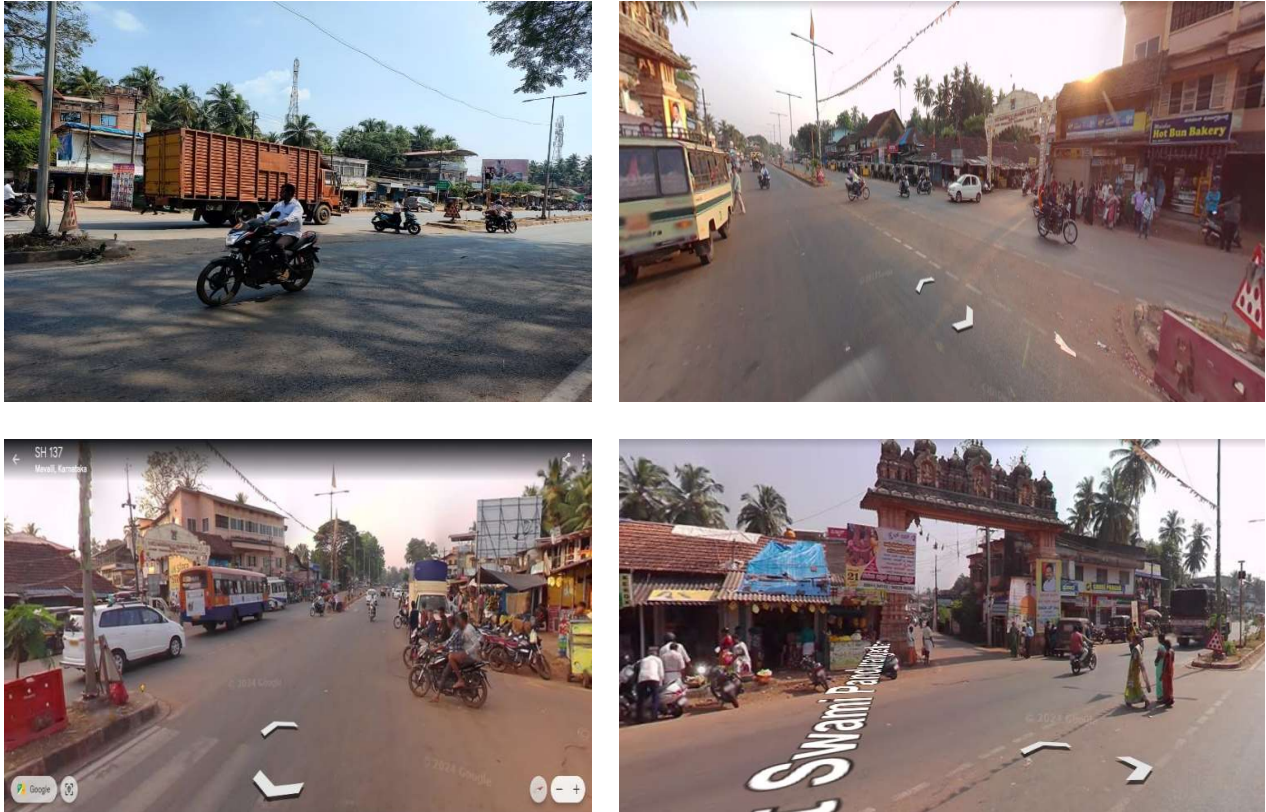
Fig 4.2: Shirali Junction

A proper bus bay is not provided. This causes buses to stop on the main road, obstructing traffic flow.

There are intersections on both sides of the bus stop. Proper turning lanes and traffic lights are not provided. This creates confusion and potential hazards for both drivers and pedestrians.

Inadequate provision for passenger safety, such as the absence of shelters, seating, and barriers can put passengers at risk while waiting for or boarding buses.

- a) Educate the public about the importance of keeping roads clear and safe near market areas.

- b) Use signs, public announcements, and community meetings to raise awareness about traffic rules and pedestrian safety.

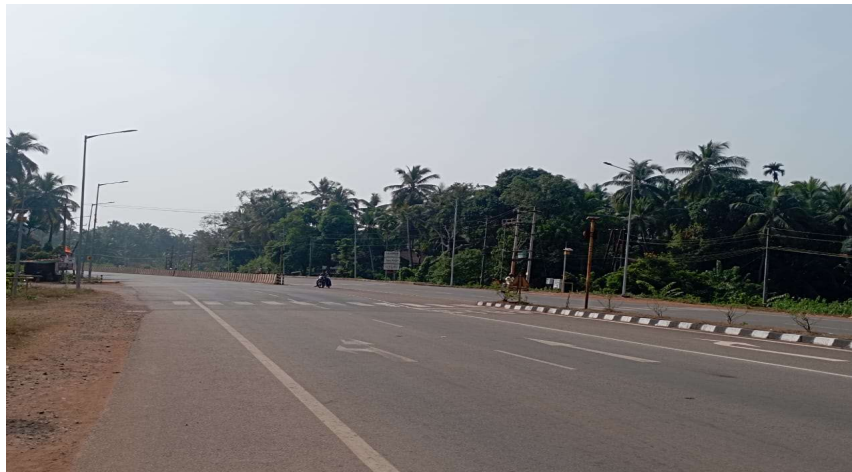
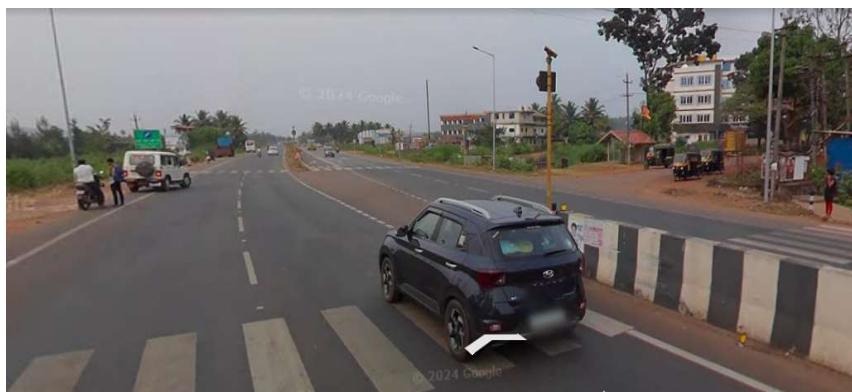
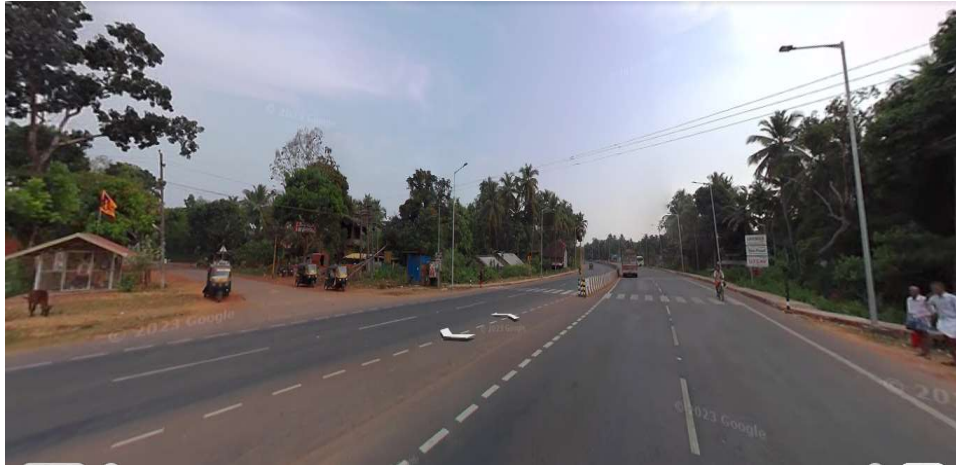
Fig 4.4: Railway Cross Karki

3) Inadequate Entry and Exit Tapers:

Insufficient passenger amenities and safety measures can lead to unsafe conditions for passengers waiting for or alighting from buses.

- a) Conduct regular maintenance of bus bays to ensure they remain in good condition, free of potholes and other damage.
- b) Periodically review the usage and condition of bus bays to make necessary adjustments and improvements.

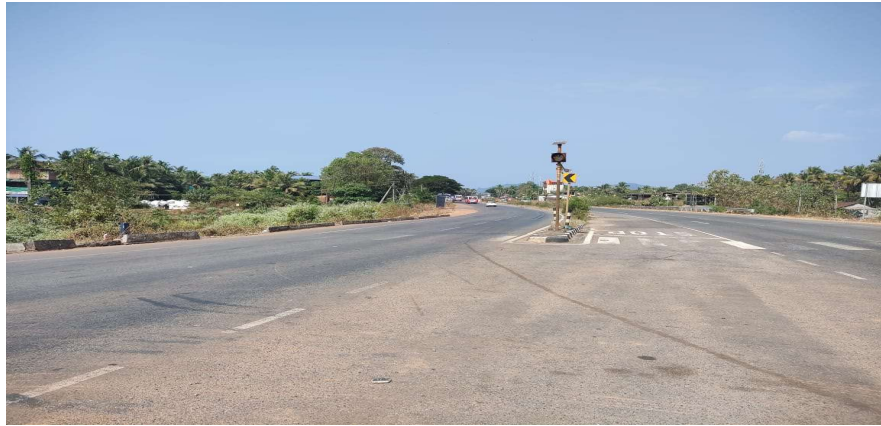
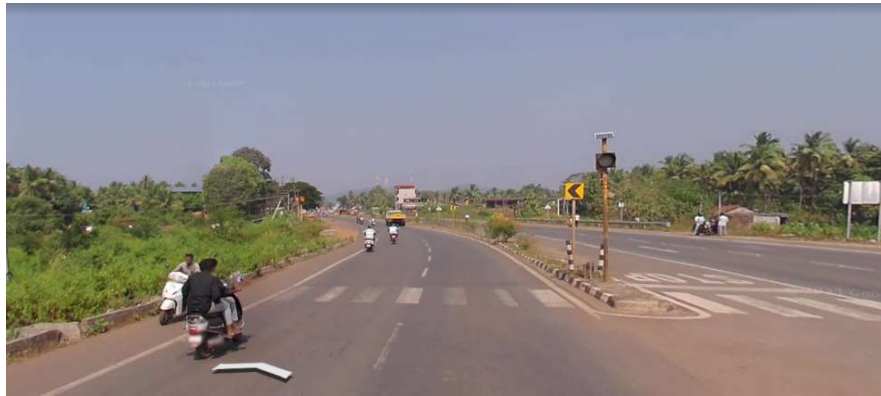
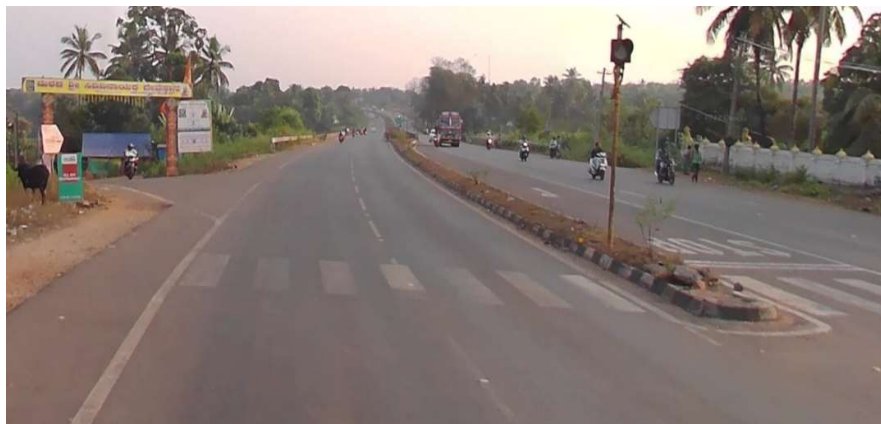
Fig 4.6 : Venktapur Village

- a) Lack of adequately marked pedestrian crossings, leading to unsafe crossing conditions for pedestrians.
- b) **Poorly Designed Footpaths:** Footpaths may be absent, too narrow, or obstructed, forcing pedestrians to walk on the road.

- 3) Improper Lighting:** Inadequate lighting at pedestrian crossings and footpaths, reducing visibility and increasing the risk of accidents, especially at night.
- 4) Lack of Traffic Calming Measures:** Absence of traffic calming measures in areas with high pedestrian activity, leading to higher vehicle speeds and increased risk of accidents.
- 5) Poor Maintenance:** Lack of maintenance of pedestrian infrastructure, leading to damaged footpaths, faded road markings, and malfunctioning pedestrian signals.

- a) Conduct regular inspections and maintenance of pedestrian infrastructure to ensure it remains in good condition.
- b) Repaint road markings and repair any damage to footpaths promptly.
- c) Ensure pedestrian signals are functioning correctly and are synchronized with traffic lights.

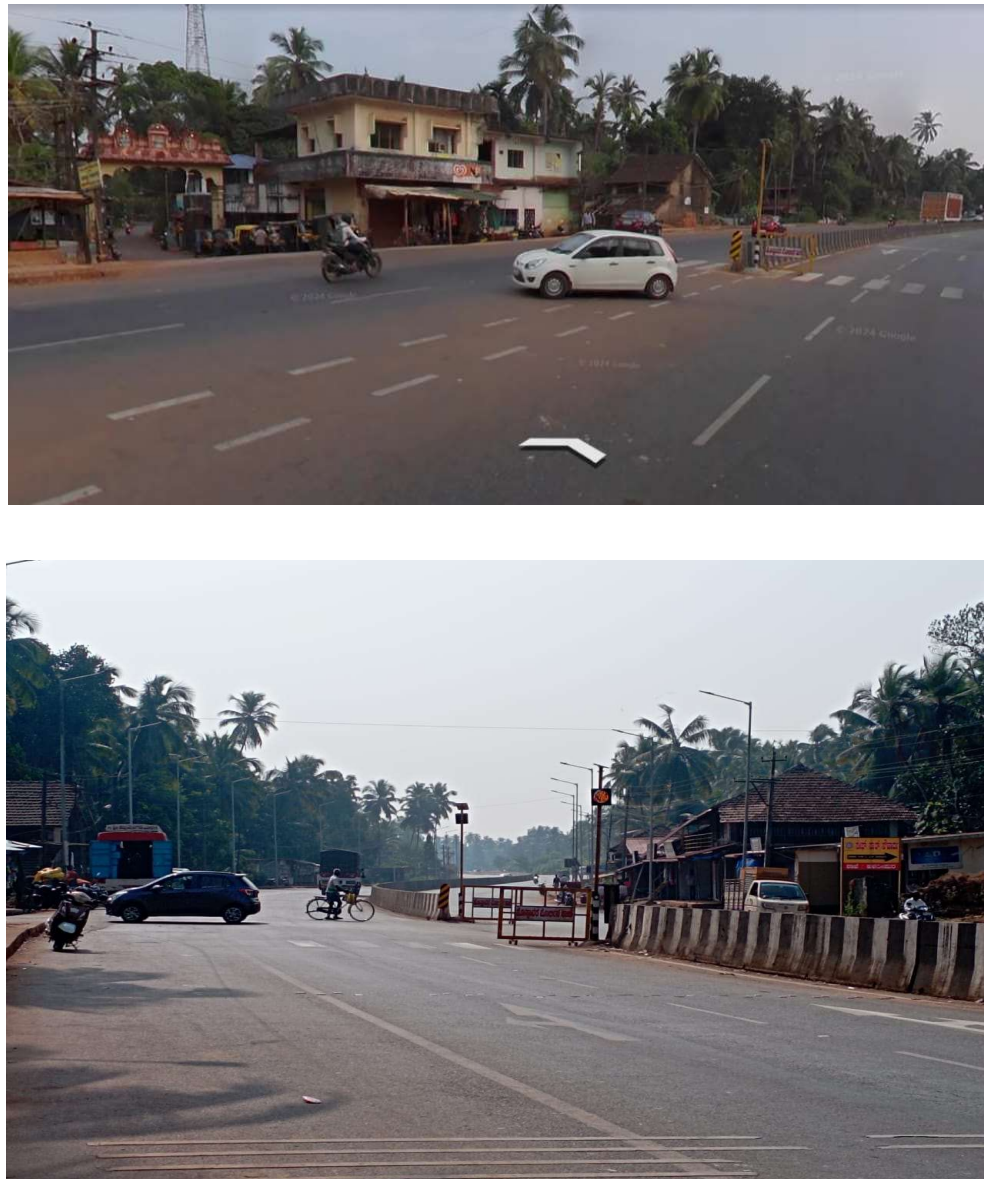
Fig 4.8 : Haldipura Location

- a) A proper bus bay is not provided.
- b) This causes buses to stop on the main road, obstructing traffic flow.

- a) Width and Accessibility: Ensure footpaths are wide enough to accommodate pedestrian traffic (minimum width of 1.5 meters recommended) and are continuous along both sides of the road. Ensure footpaths are free from obstacles and are accessible for all, including persons with disabilities, by providing ramps and tactile paving.
- b) Maintenance: Regularly inspect and maintain footpaths to keep them in good condition
